US Army Corps
of Engineers

REPAIR, EVALUATION, MAINTENANCE, AND
REHABILITATION RESEARCH PROGRAM

TECHNICAL REPORT REMR-CS-34

LABORATORY EVALUATION OF CONCRETE MIXTURES AND TECHNIQUES FOR UNDERWATER REPAIRS

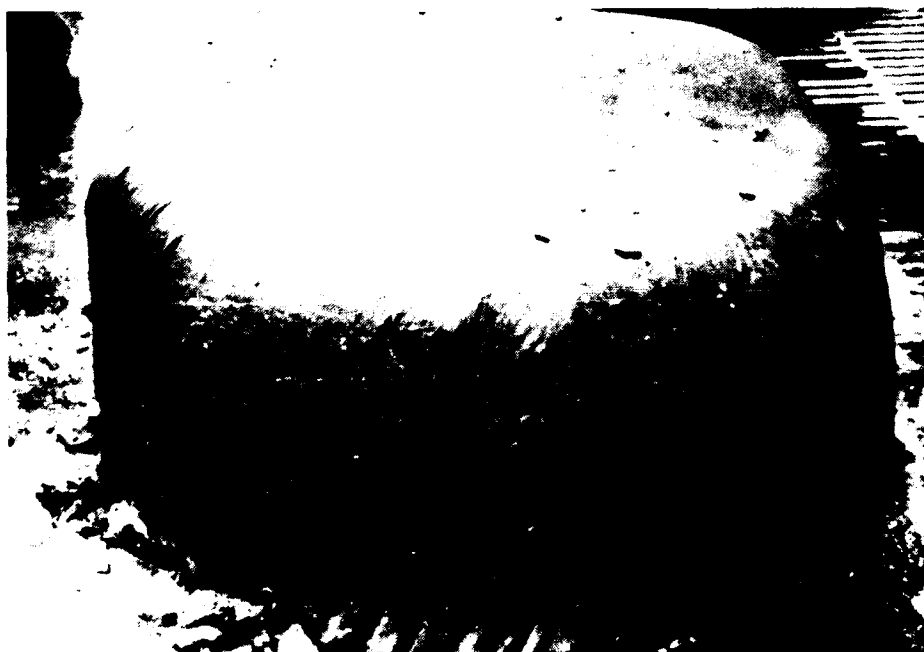
Figure 10. Solid mass of concrete after hardening, trial 2

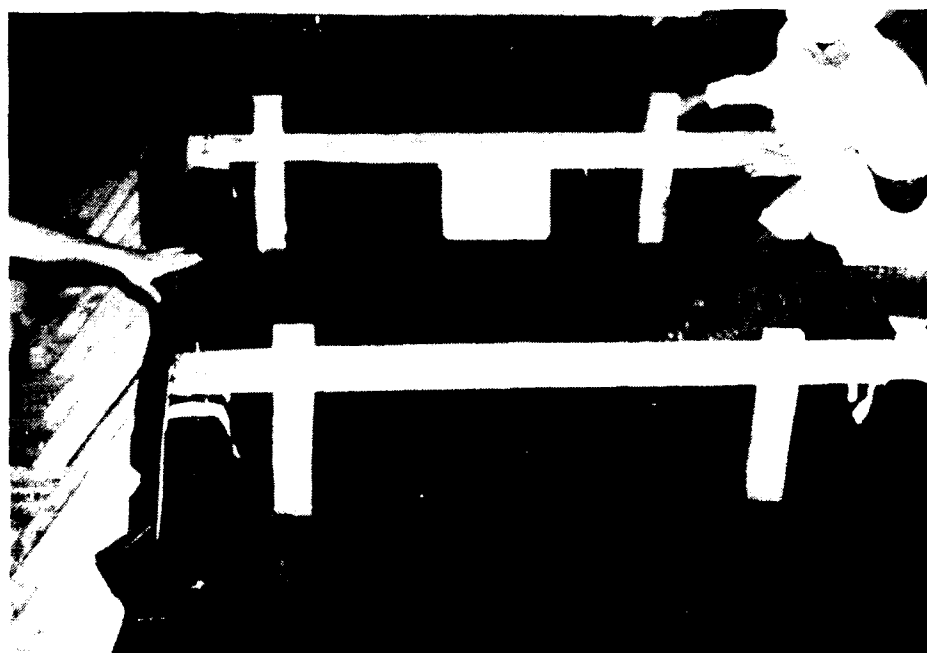
Figure 19. Concrete pumped into box, trial 4

13. Four cubic yards of concrete mixture 78 was batched in an eight-cubic-yard transit mixer as described in trial 3. The concrete was deposited into the tank, the beam mold, the abrasion molds, and the large box by a trailer pump with a 5-in. line. The pump was rated at 120 cu yd/hr with a maximum pressure of 4,500 psi. The concrete was pumped approximately 25 ft with a pressure of 300 to 400 psi into each container as described in trial 3 (Figures 17 through 19). The concrete was more fluid in this than in trial 3 and moved well underwater. With only a small loss of fines observed in the water, the concrete placement could be seen through 4 ft of water (Figure 20). Figure 21 shows the two hardened abrasion specimens.

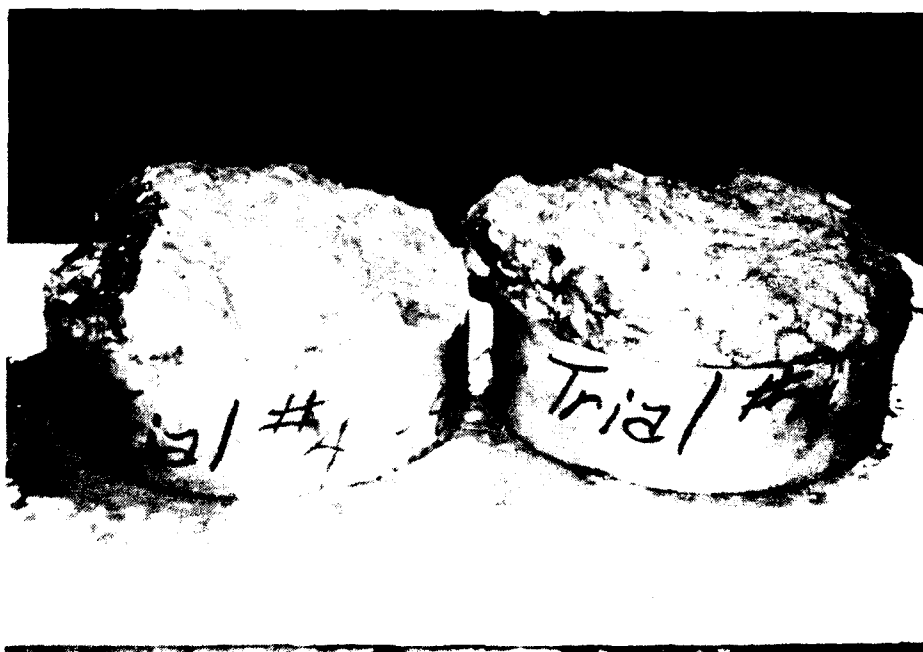
Figure 21. Hardened abrasion specimens, trial 4

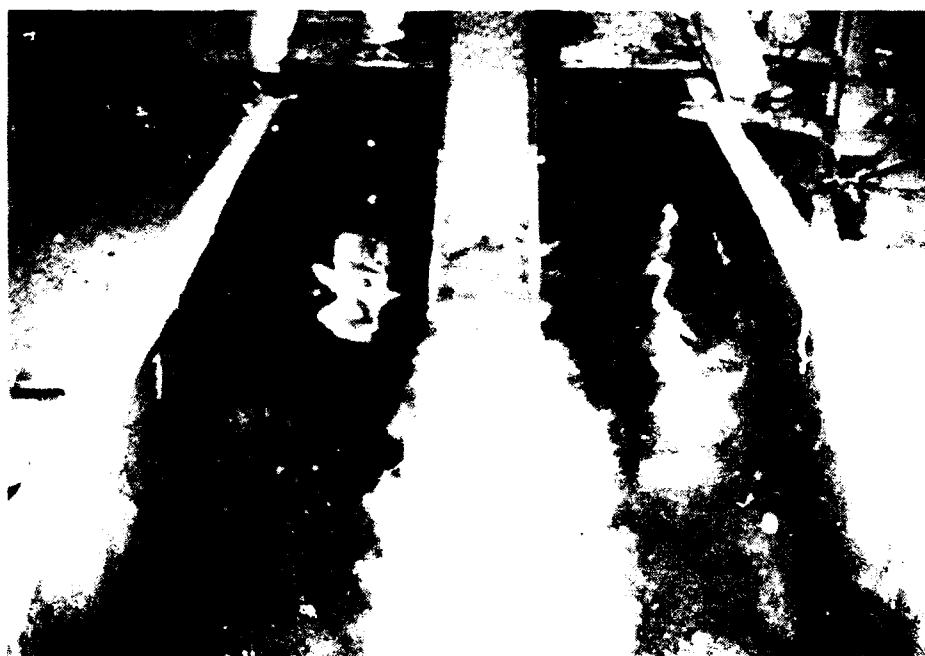
Figure 29. Clouding of water during concrete placement into box with inclined tremie, trial 9

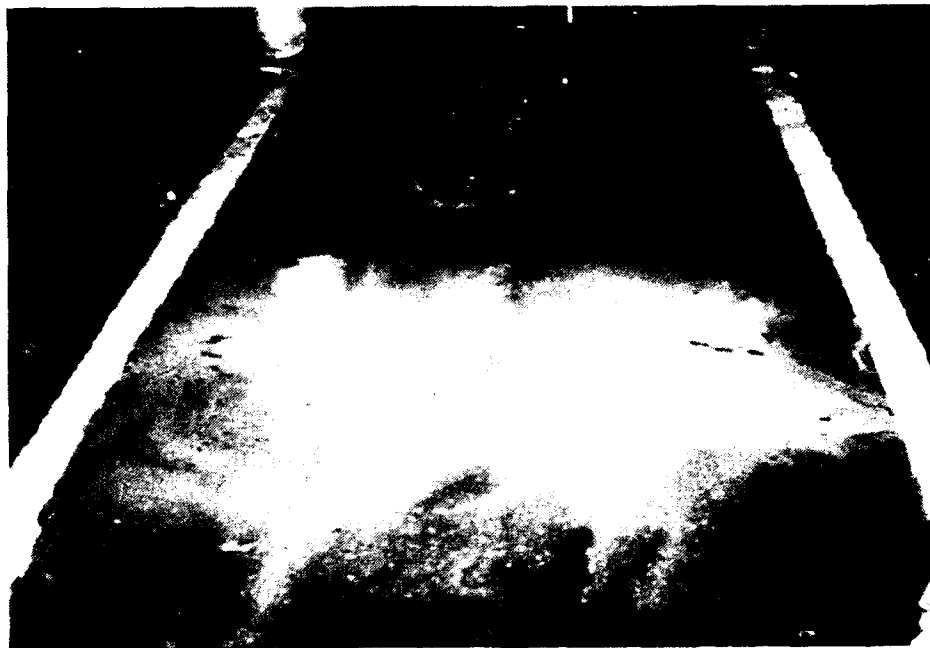
Figure 30. Froth collected on top of water after concrete placement, trial 9

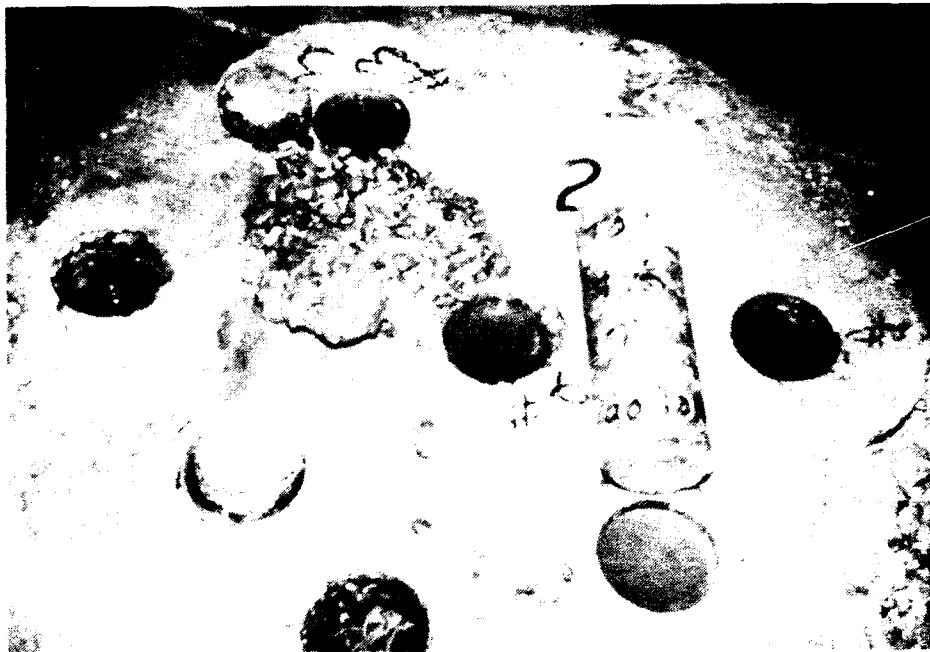
Figure 72. Cores taken from concrete placed in steel tank, trial 2
